ASPHALT TECHNOLOGIES, INC.

TEST & EVALUATION REPORT Shingle Rejuvenator Benchmark Life-Cycle Study

September 1, 2023

Report For: Greener Shingles Rejuvenator
Saskatchewan, Canada

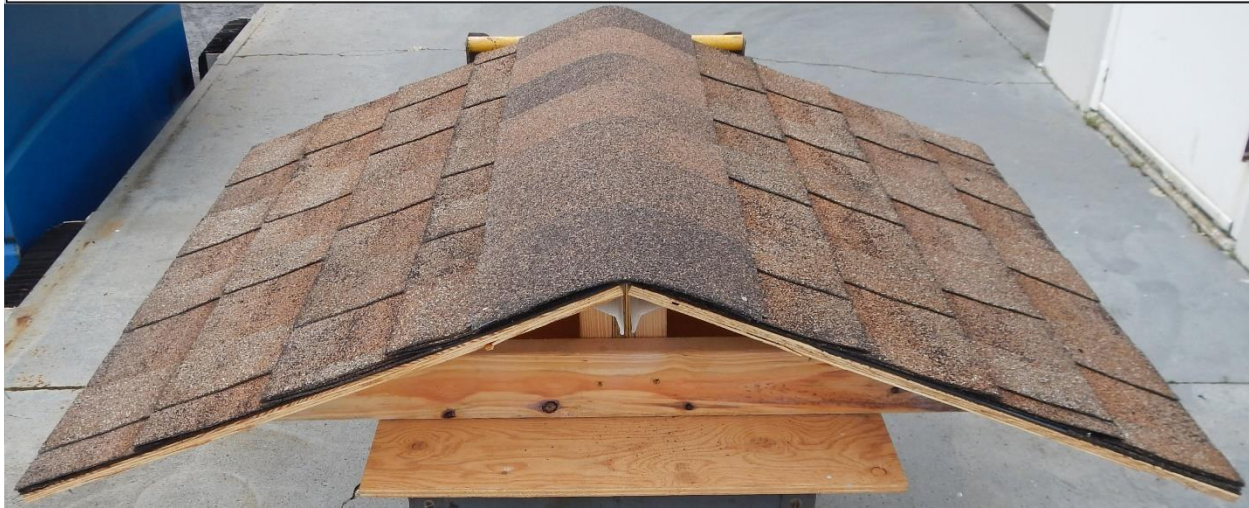
APPENDIX A-1 (Roof Deck Construction):

Completed Roof Deck Before Rejuvenator Application

A type of common, commercially used ridge-cap shingles were then cut and applied to the cap of the roof deck. The cap was selected for the closest visual match to the shingles used.

The study used a miniature steep sloped roof, constructed at PRI made with commonly used stock material (2X4's, plywood, peel-n-stick underlayment, and stainless-steel roofing nails). Both slopes were roofed with the aged shingles, with one side being treated with Greener Shingles rejuvenator and the other side being an un-treated roof deck. The rejuvenator was applied according the manufacturer's recommendations. See appendix for photos and details of construction

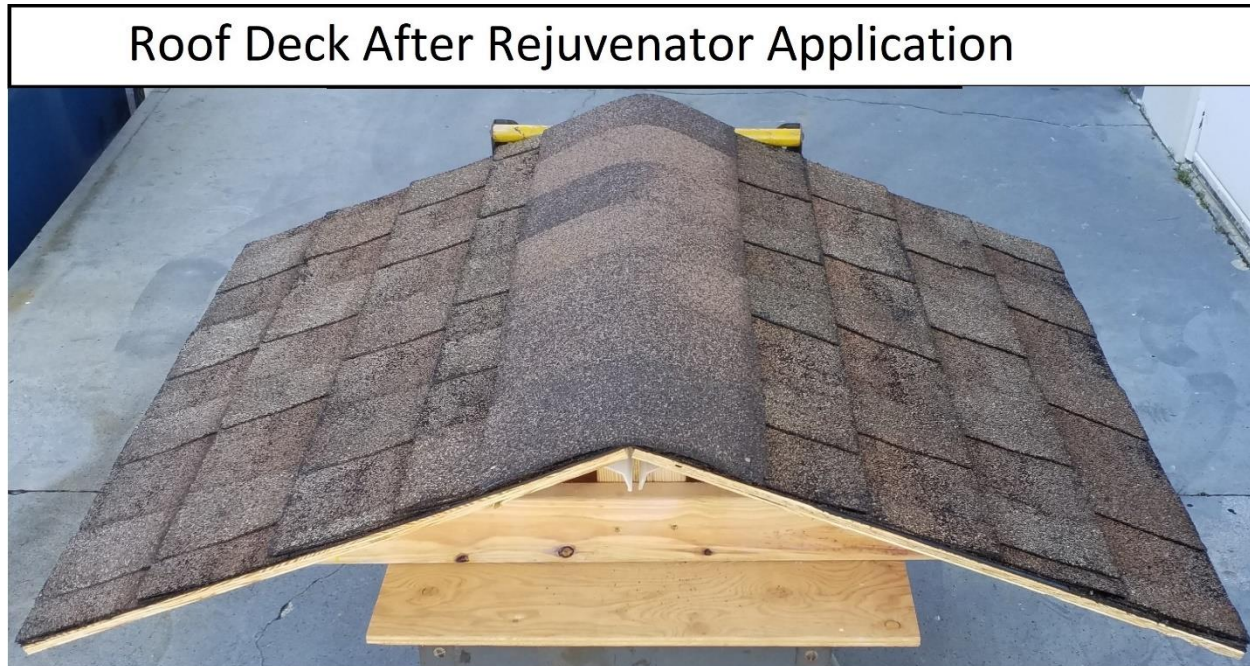
APPENDIX A-2 (Roof Deck Construction):

Application of Rejuvenators:

The Greener Shingles Rejuvenator was prepared and applied according to manufacturer guidelines using common garden spray bottles and allowed to cure for 24 hours:

- Manufacturer recommendations – A mixture of 70% water and 30% Rejuvenator concentrate stirred by hand to homogeneity.
- The product was applied were to one side of the roof deck at a target rate of 1 gallon per 100ft² using simple spray bottles.
- The other side was left un-treated.

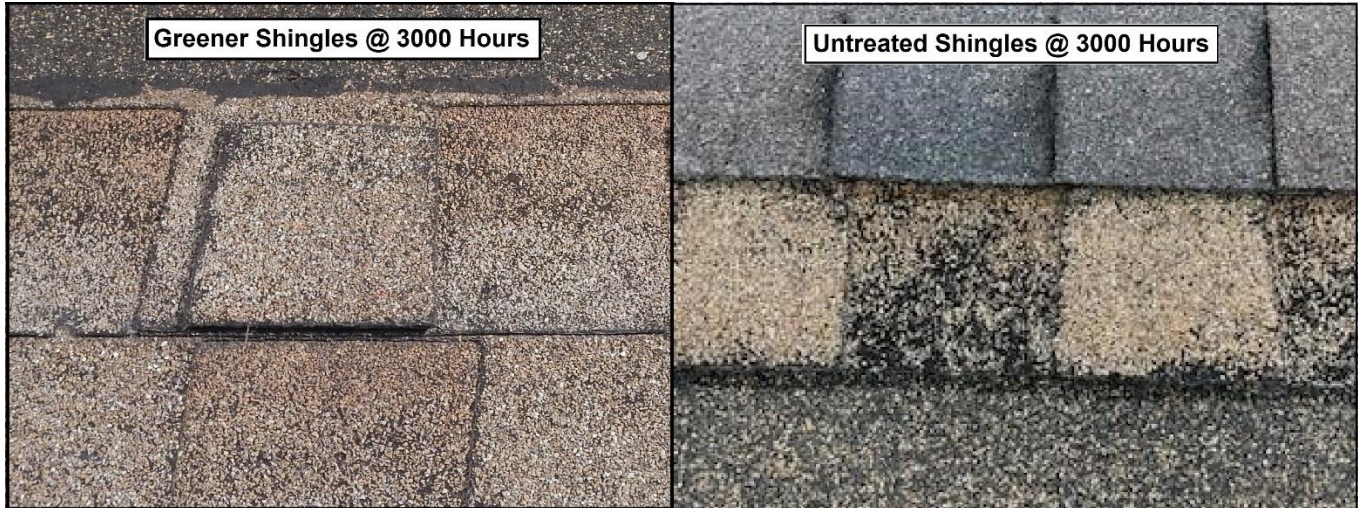
APPENDIX A-5 (Shingle Appearance Comparison – ~3000 hours):

There is a notable difference in appearance between the untreated and treated shingles after 3000 Hours.

- **Shingle Color and Appearance:** After 1,500 and 3,000 hours of exposure, the shingles treated with Greener Shingles Rejuvenator exhibit a significantly different appearance than those left un-treated.

- Un-treated shingles show a clear increase in the roofing granules lost. (Appendix A-4/5)
